National Dam Safety Program. Willow Brook Dam (Inventory Number NY 35). Lower Hudson River Basin, Orange County, New York. Phase I Inspection Report.

TITLE
Phase I Inspection Report
Willow Brook Dam
Lower Hudson River Basin, Orange County, NY
Inventory No. 35

PHASE I INSPECTION REPORT
NATIONAL DAM SAFETY PROGRAM
WILLOW BROOK DAM
I.D. No. NY 35
DEC DAM No. 195C-450
LOWER HUDSON RIVER BASIN
ORANGE COUNTY, NEW YORK

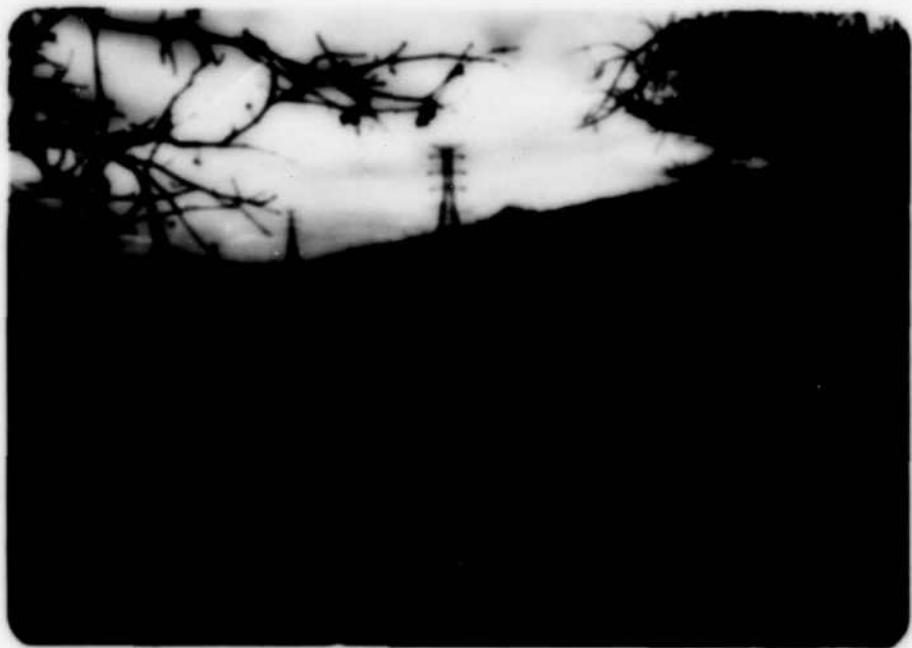
- b. Spillway - The upstream ends of the wingwalls are undercut and show signs of deterioration. The concrete caps for the masonry walls at the spillway weir are missing (as shown in Photo 4). In the spillway discharge channel, there are some minor cracks in the masonry walls above normal water level. A few boards were found in the channel at the rock rubble falls, and tree branches were in the channel near the confluence with the outlet works channel.

Photo 4. Spillway
9 March 1981

- b. Condition of Service Spillway The spillway is in good condition with no deterioration observed. The upstream ends of the wingwalls are undermined and are showing signs of deterioration. The concrete caps for the masonry walls at the spillway crest are missing.

1. The low area of the dam crest on the left side of the spillway should be filled to the average elevation of the top of dam, 590.0 M.S.L.
2. The deterioration in the spillway wing walls should be repaired and rock riprap should be placed at the junction of the wing walls and dam to prevent undercutting.

9. The missing concrete caps for the masonry walls at the spillway weir should be replaced.
